DEFENSE ATOMIC SUPPORT AGENCY WASHING
BIKINI SCIENTIFIC RESURVEY. VOLUME II
DEC 47

Bikini Scientific Resurvey, Annex I

SARATOGA: GENERAL DESCRIPTION OF DAMAGE

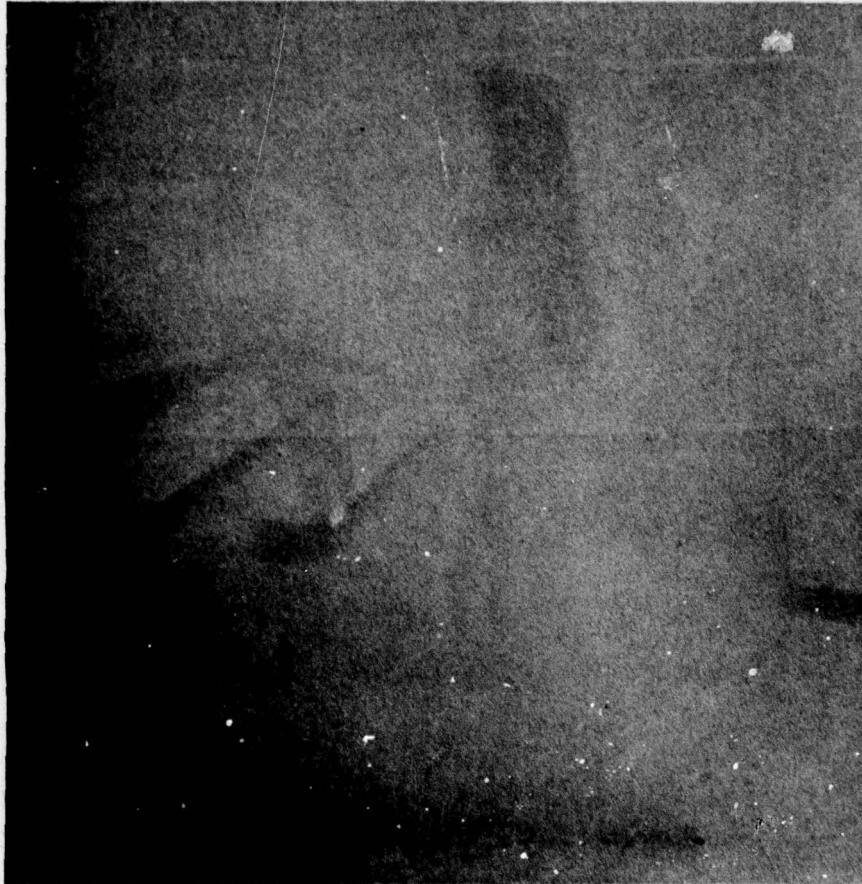
Pallisades, showing distorted and raised pallisades. ABCR
Photo No. 6002-7.

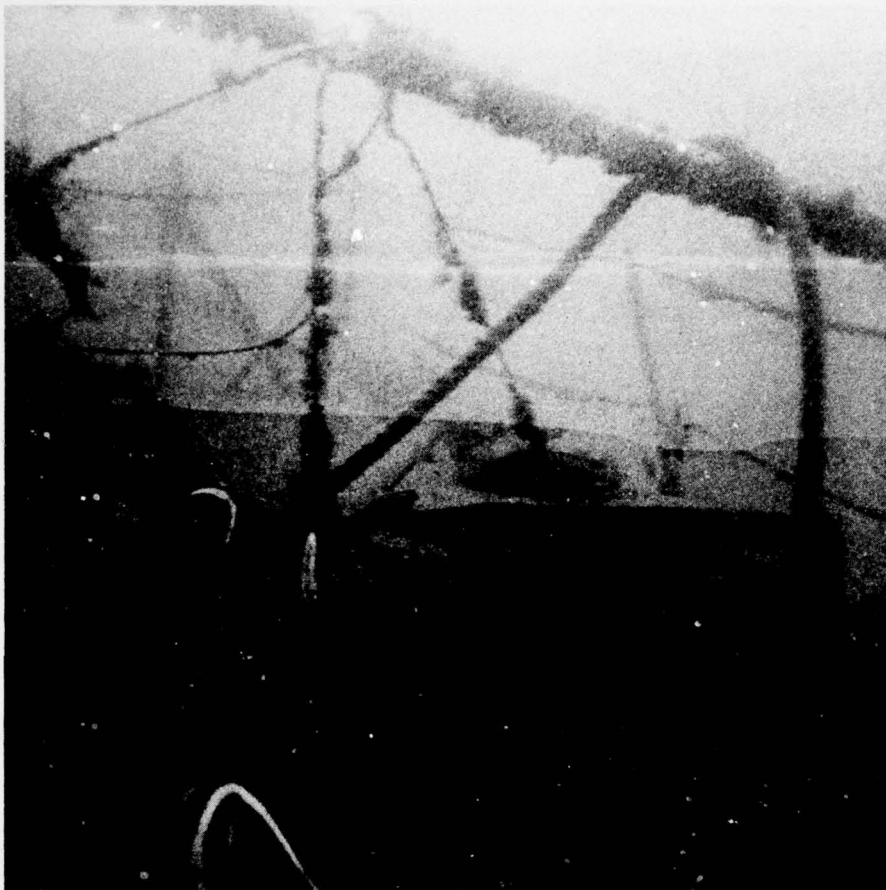
Radio Antenna starboard forward bow bent inboard. ABCR Photo
No. 6002-12.

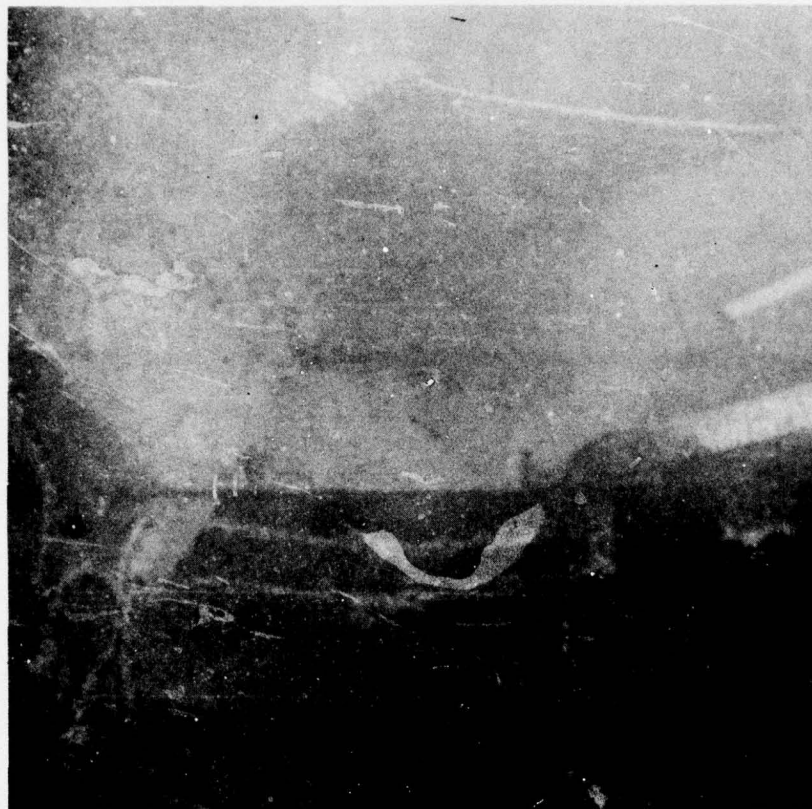
#1 uptake in forward edge of uptake looking down and aft.
ABCR Photo No. 6005-29.

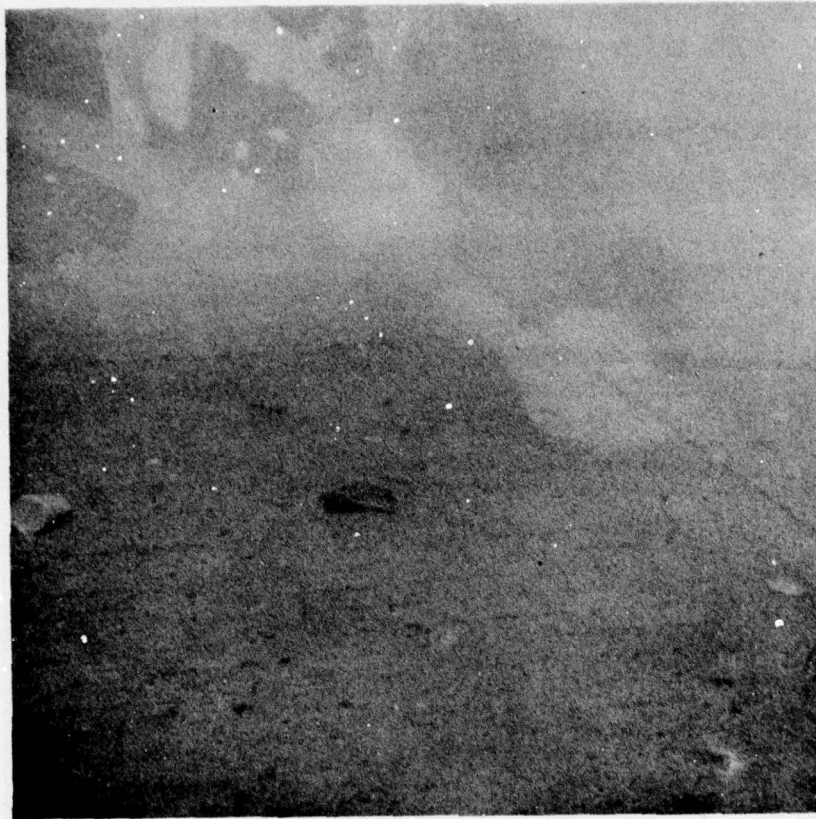
View of starboard catapult and plane securing track showing double warped surface of flight deck forward. ABCR Photo No. 6007-2.

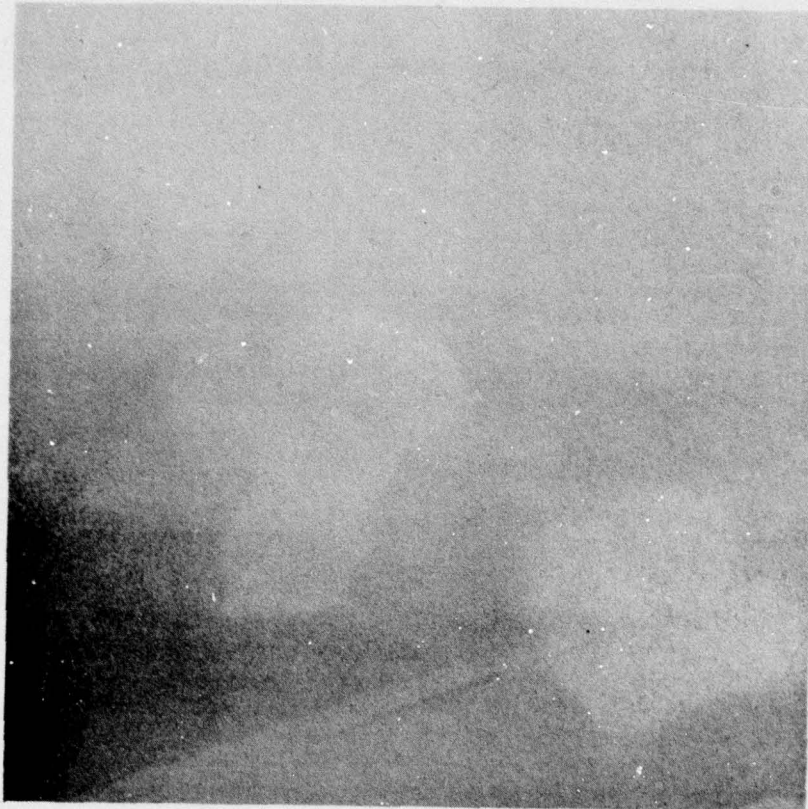
Aircraft elevator showing relative position in hatch. ABCR
Photo No. 6007-5.

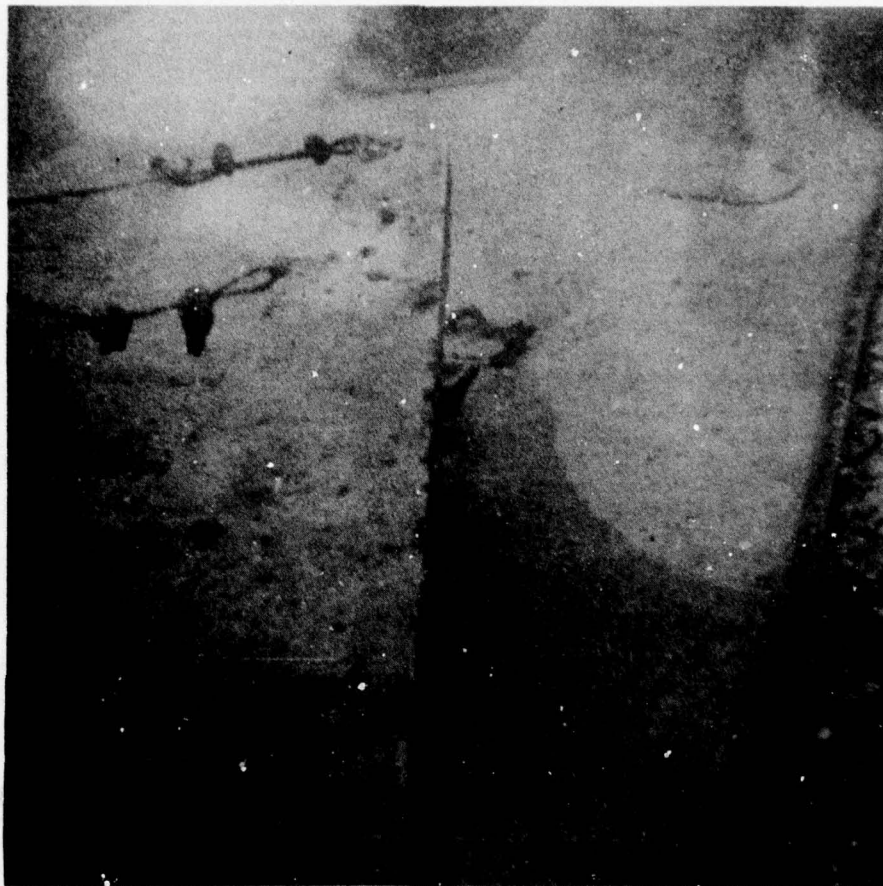
View on flight deck showing side of barrier. ABCR Photo No. 6015-4.

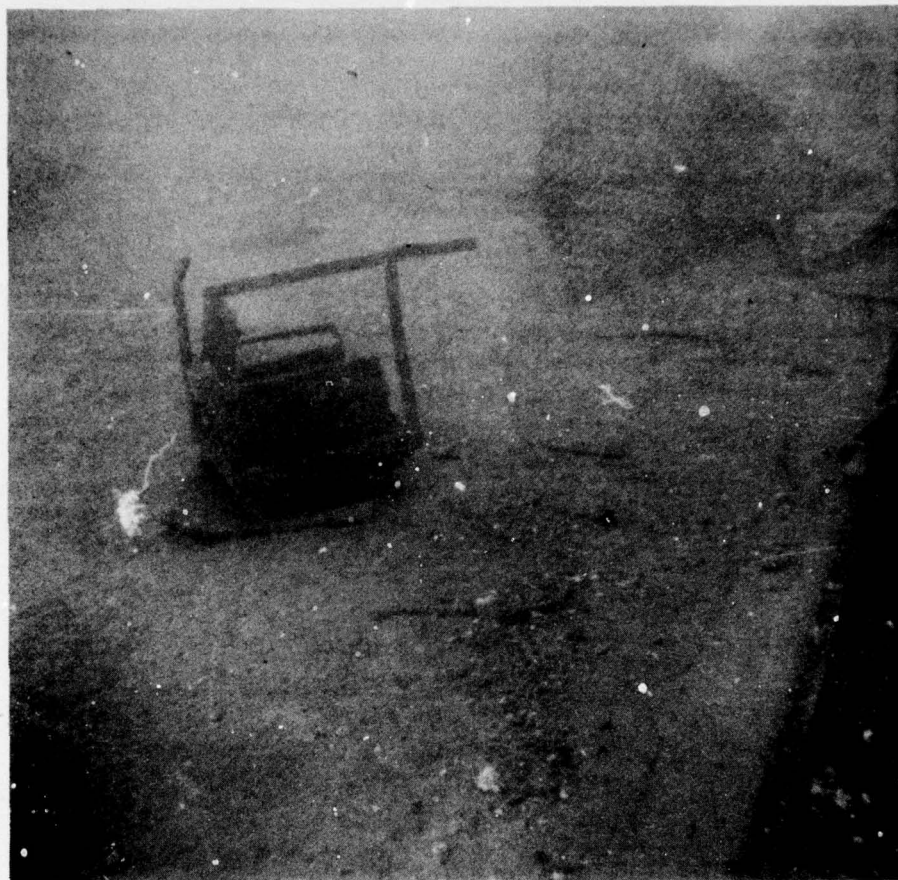
Debris on flight deck. ABCR Photo No. 6017-4.

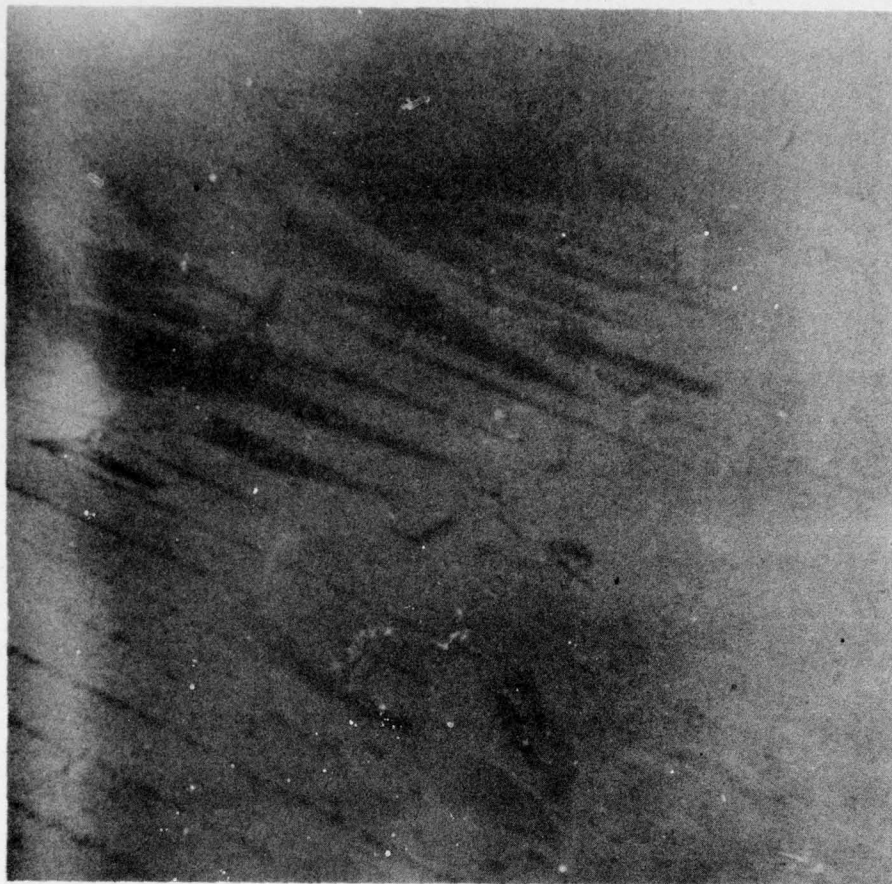
Looking aft on starboard side flight deck about frame 160.
ABCR Photo No. 6021-1.

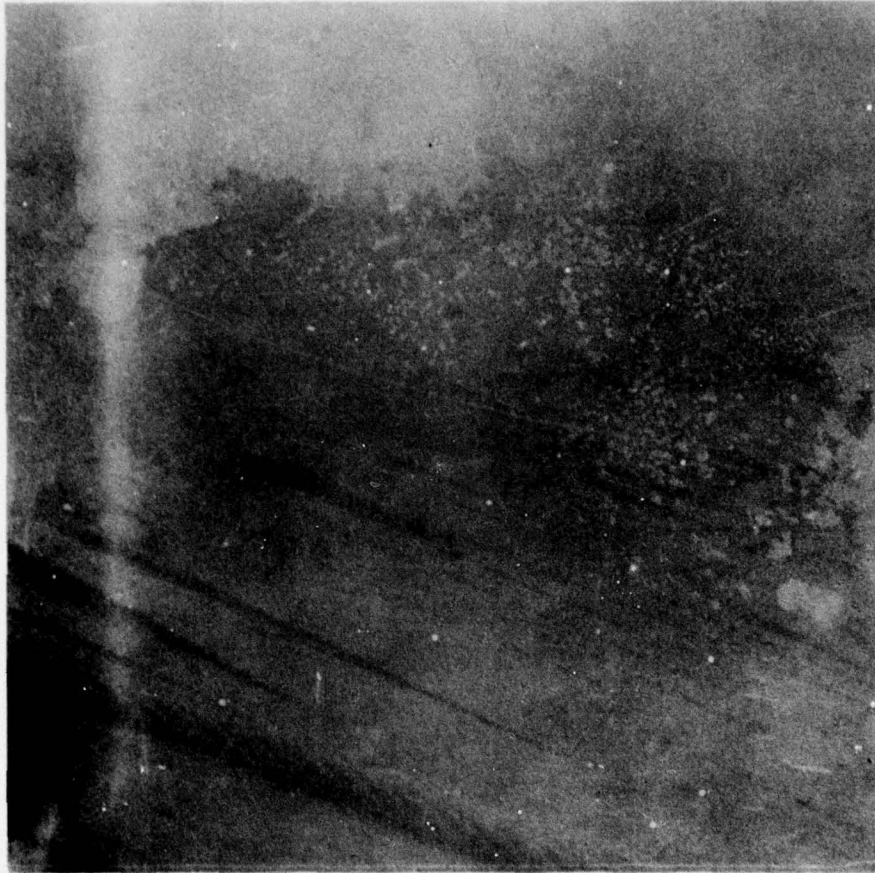
Looking aft on starboard side of flight deck about frame 162.
ABCR Photo No. 6021-2.

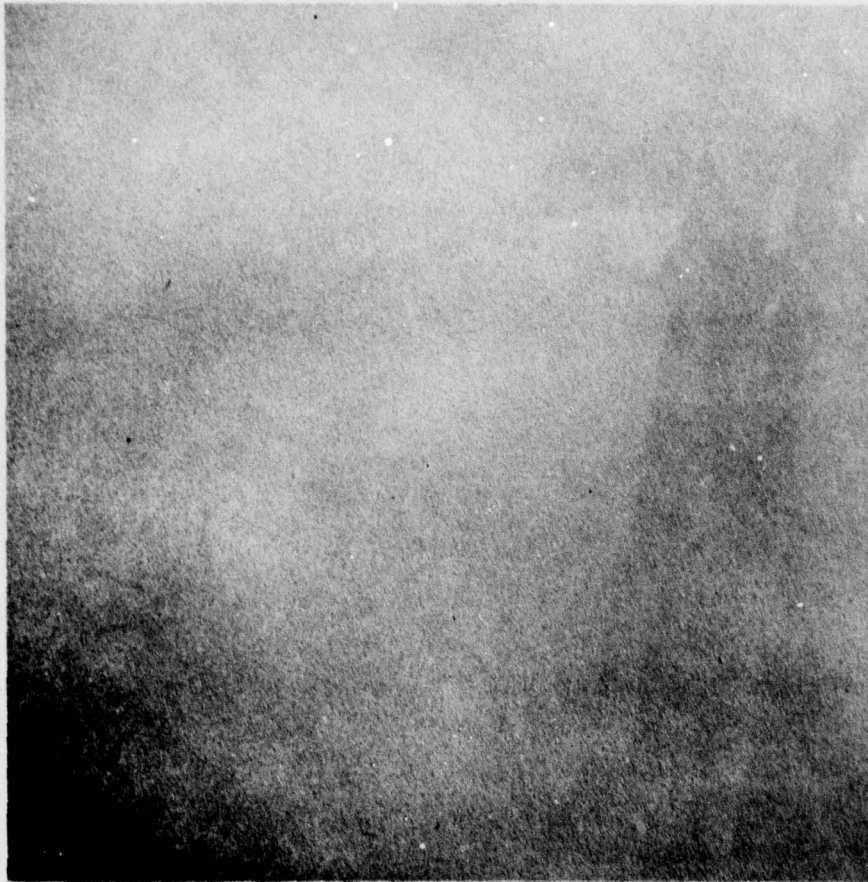
Gun barrel and debris around 40mm gun mount #13, frame 112
starboard. ABCR Photo No. 6025-2.

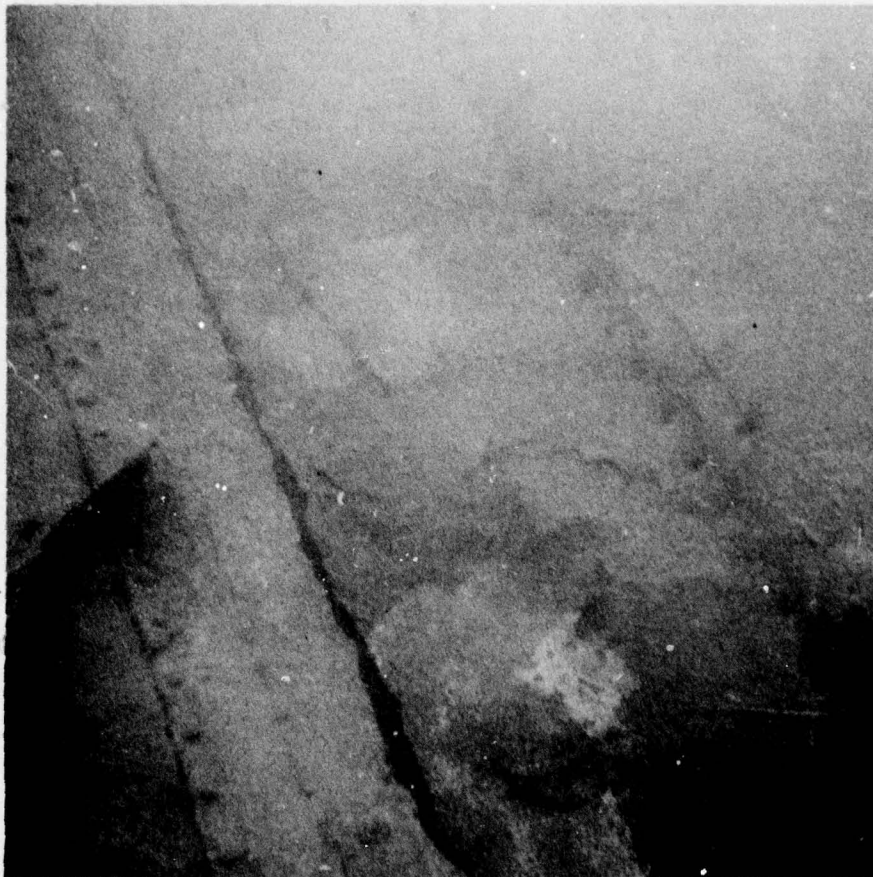
Rip in stack. ABCR Photo No. 6026-4.

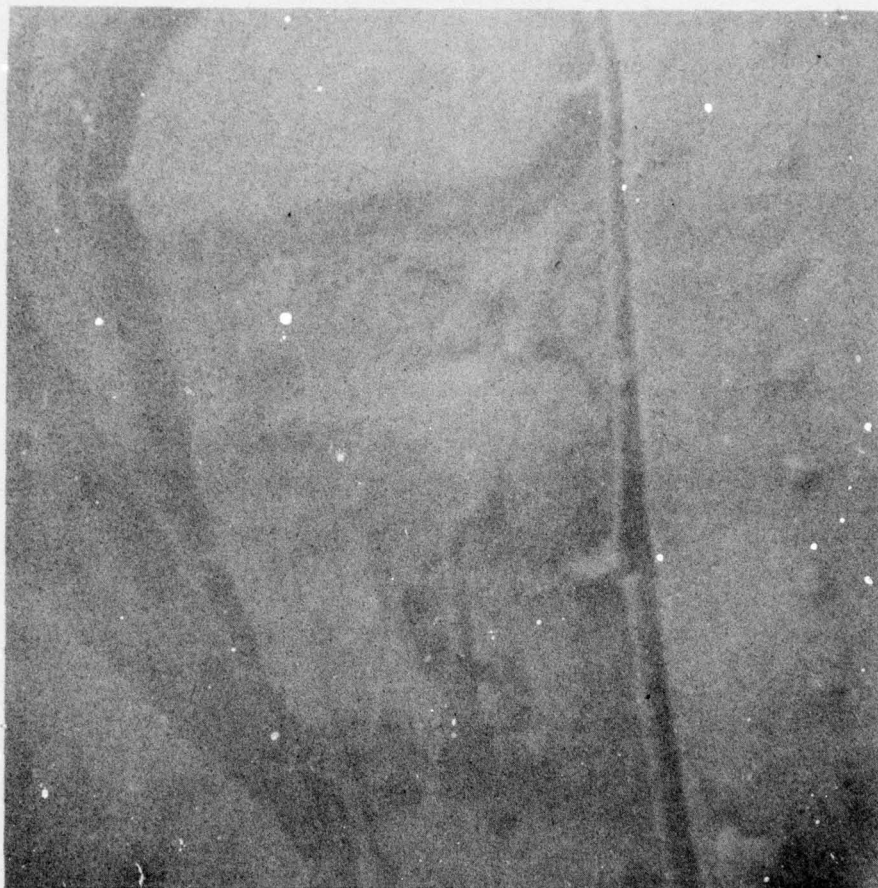
Water tight door sprung, aft of frame 125, starboard side of deck house. ABCR Photo No. 6026-5.

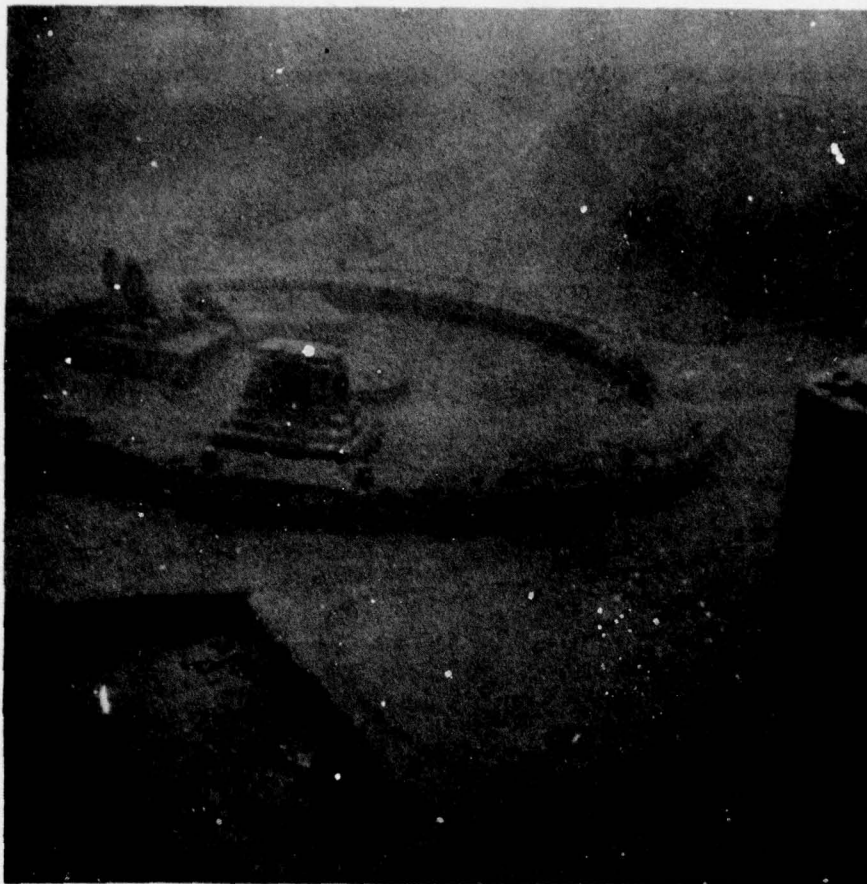
5" 38 Cal. gun ring showing gages used during test "A" and "B". ABCR Photo No. 6026-7.

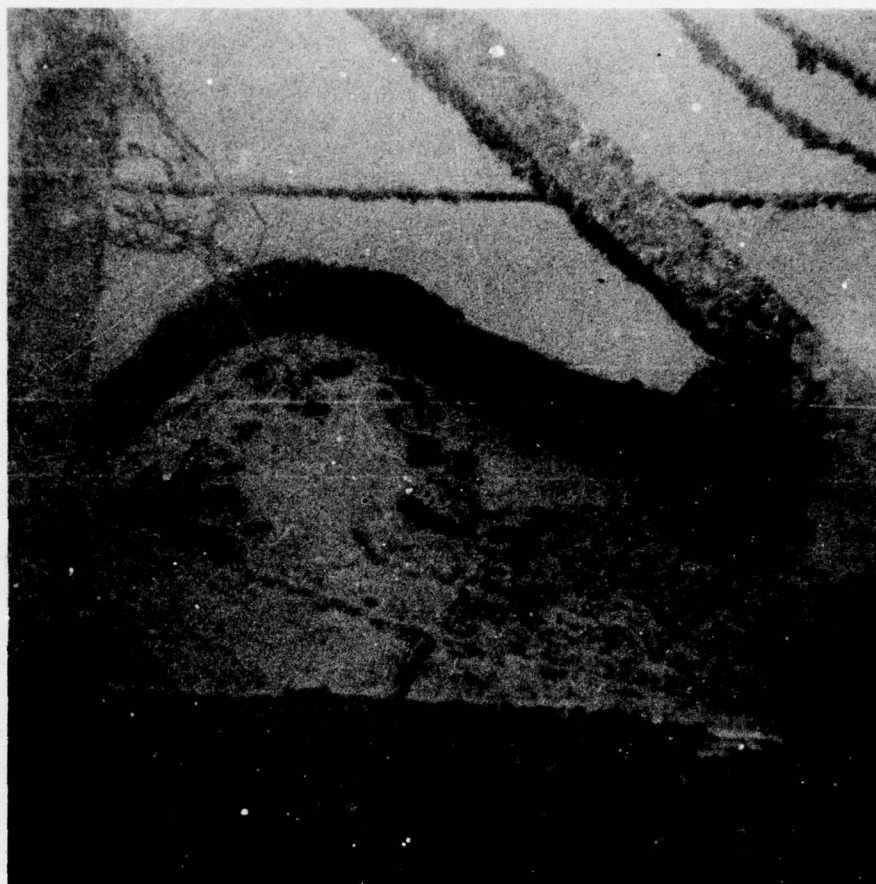
Edge of flight deck, about frame 192, starboard side, at start of break. ABCR Photo No. 6029-8.

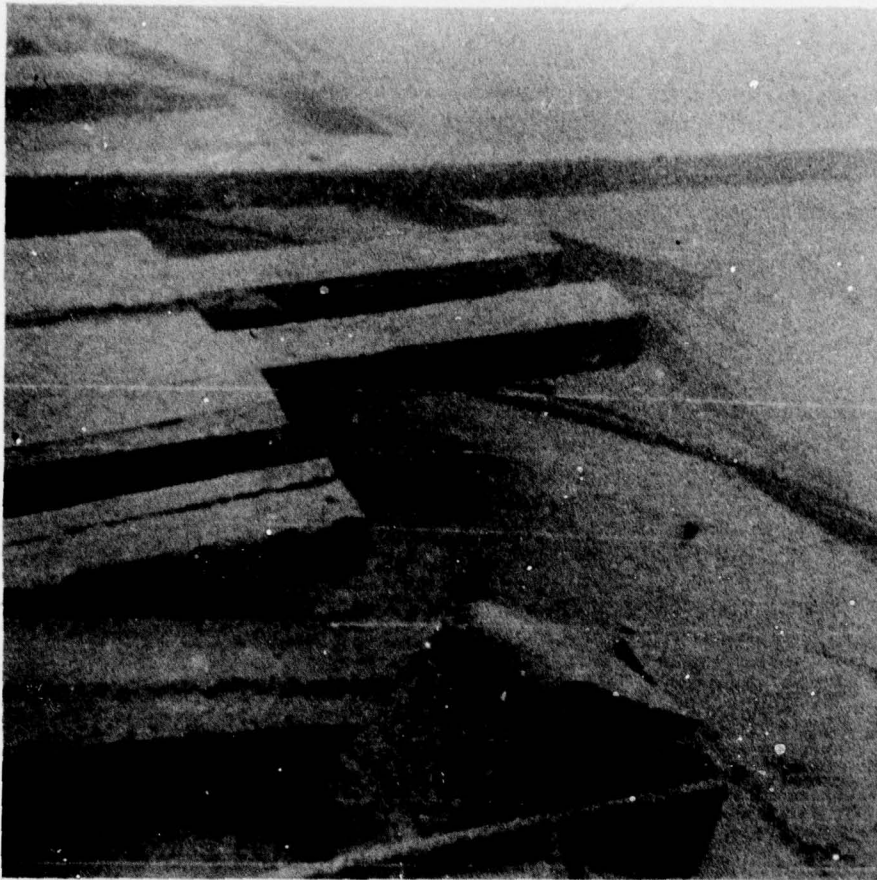
#3 in a series of pictures taken along starboard edge of flight deck about frame 132. ABCR Photo No. 6029-12.
